**Arboricultural Assessment of a tree growing at
40, Guinea Street, Bristol.**

On behalf of:
Hugh

Prepared by:
Chris Wright M.Arbor.A
Arboricultural Consultant
January 2024

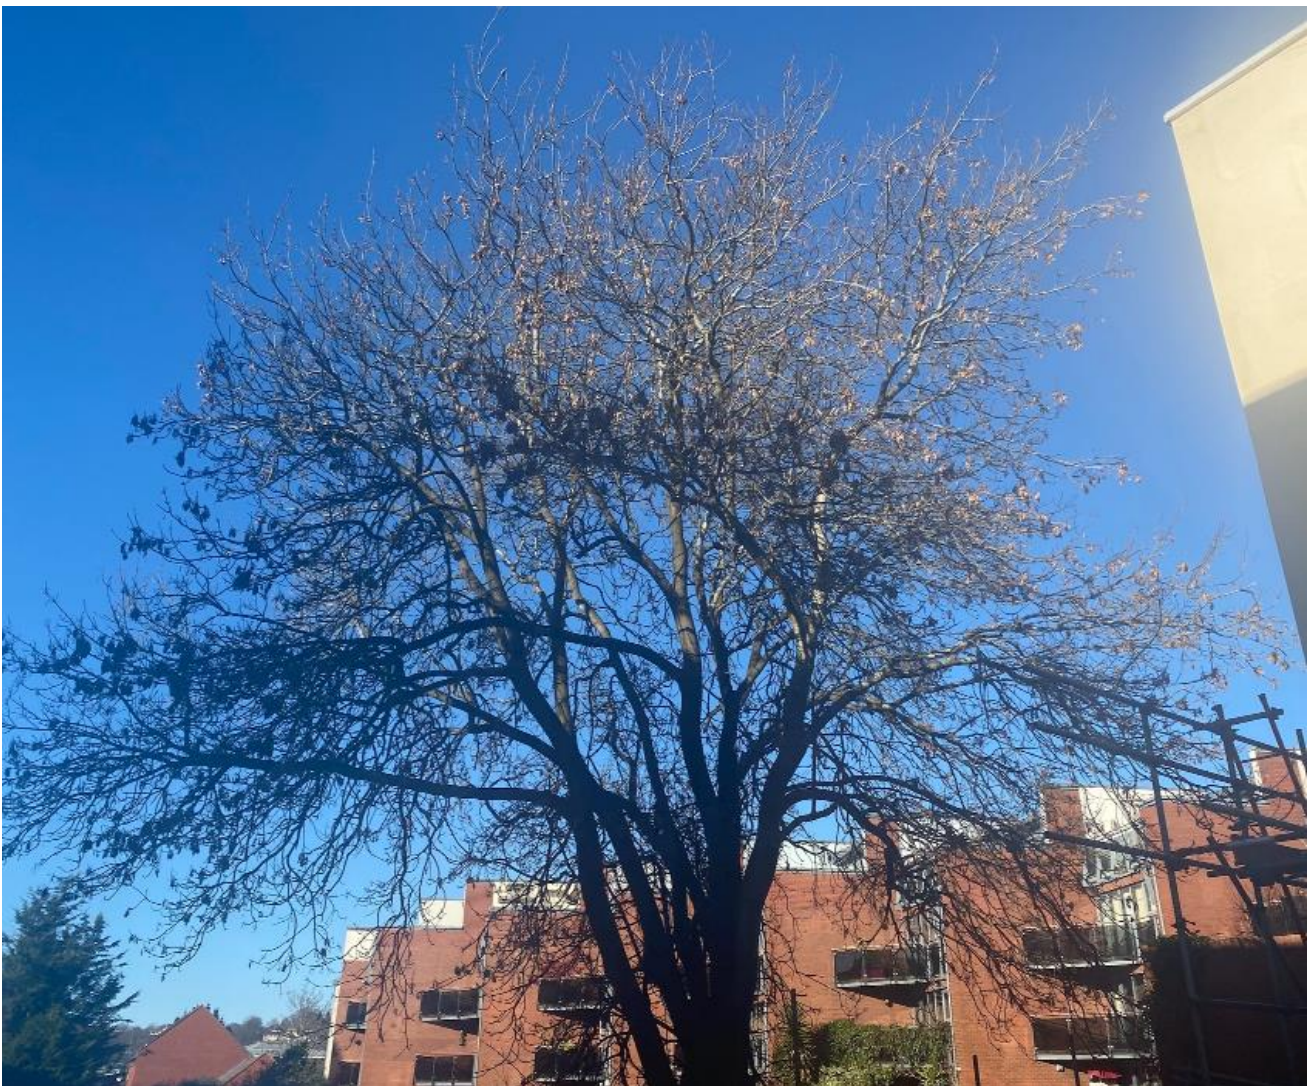
- 4.1 The tree is a mature Ash tree (*Fraxinus excelsior*) currently approximately 12m tall with an average crown spread of 6m. The tree has a multi-stemmed structure from approximately 0.5m with evidence of included bark at the stem union.
- 4.2 The southern canopy of the tree extends over the adjacent public footpath and highway with two main stems leaning to the south from the base. A section of the northern canopy overhangs Redcliffe Railway cutting.
- 4.2 The canopy of the tree contained significant amounts of major deadwood and minor dieback. Extensive epicormic growth was present on the main branches throughout the canopy which is considered to be stress a reaction from the tree. We were informed that the foliage of the tree was sparse last year.

- 4.3 Due to the extent of dieback and epicormic growth it is considered that the tree is infected by Ash dieback disease (*Hymenoscyphus fraxineus*) Ash dieback disease destroys the tree's phloem and xylem, which results in the tree being unable to move water and nutrients around its structure. This lack of water and nutrient movement will cause the branches of the tree to fail and the tree to 'die back'. The ongoing loss of nutrition and water plus the depletion of energy reserves due to the lack of foliage, causes the tree to become brittle, lose branches and make it susceptible to other pathogens such as Honey Fungus (*Armillaria*).

The tree is a mature tree with major limbs extending over the adjacent public highway, footpath, parking areas in Redcliffe Railway cutting and neighbouring property. It is considered that the dieback and epicormic growth throughout the canopy is a result of Ash Dieback Disease. The presence of this disease will compromise the structural integrity of the branches and main structure of the tree potentially resulting in catastrophic failure.

Due to the potential threat to the public highway, footpath, parking area and neighbouring property it is considered that the tree poses a major health and safety risk.

It is recommended that the Ash tree is removed.

It is recommended that following the removal of the ash tree, the stump is ground out and a European Lime (*Tilia x europea*) is planted as a replacement. The replacement tree should be planted as Heavy Standards with a girth of 12-14cm at 1m, approximately 3.5m tall, which should be sourced from a local tree nursery as a root-balled tree.
